Increasing System Reliability Through Repairing the S Phase Hotspot Clamp in Circuit Breaker in The Reactor Bay of the Nagan Raya Substation

Electrical Engineering Study Program
Universitas Pembangunan Panca Budi

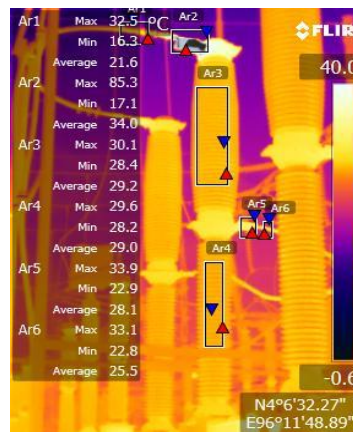
Figure 3. Thermovision before repair

Thermovision before repairing the Clamp in PMT Phase S Bay Reactor

Based on the thermovision and visual results carried out by the GI Operator where the S phase shows a higher temperature than the other phases, this has indicated recommendations from the thermovision measurement results that improvements will be made.

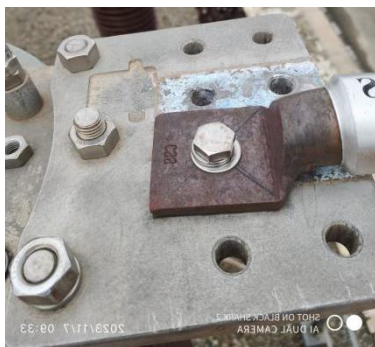
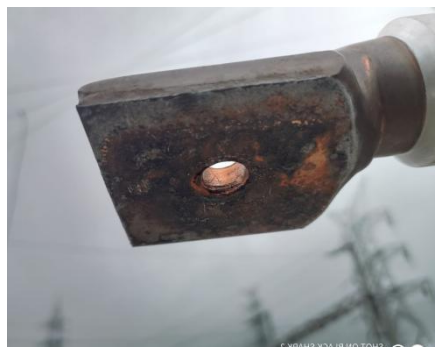
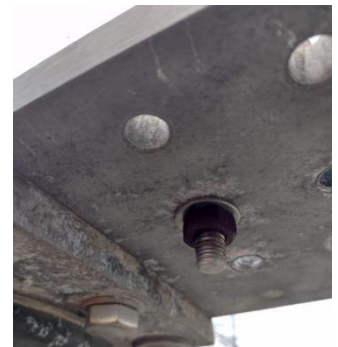
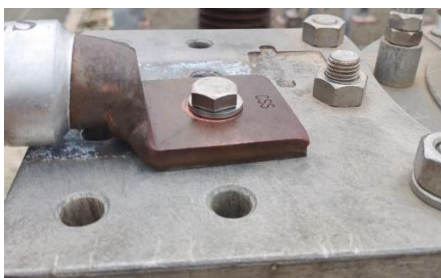
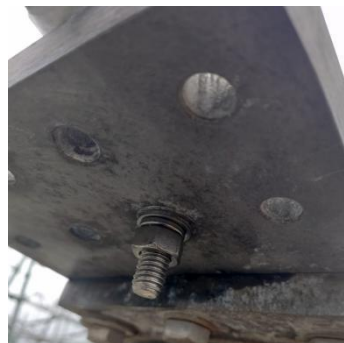
Figure 6. Discovery of Dirty Clamps and Rusty Bolts

- a. Cleaning Clamp and Replacing bolts
 - b. Reinstall the clamp
 - c. The repair process is complete
 - d. Carry out the normalization process for the Meulaboh GI Reactor Bay (Maneuver by the Substation Operator)
4. Thermovision after repair of Clamp in PMT Phase S Bay Reactor

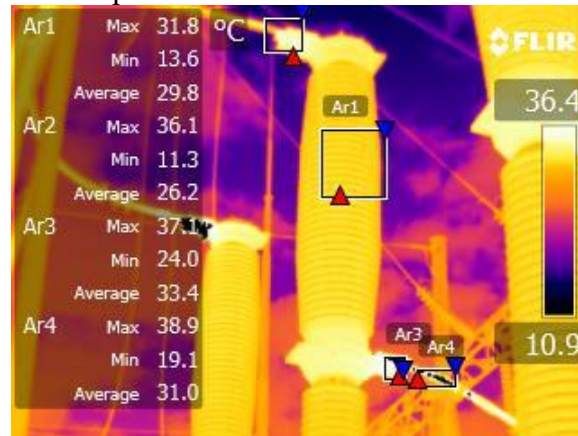
Figure 7. Thermovision after repair

The thermovision results after repair were 36.1 °C
